# CASE STUDY FOR ONBOARD SAFETY MEETING

## GROUNDING INCIDENT AND DAMAGE TO BUOY IN THE SUEZ CANAL

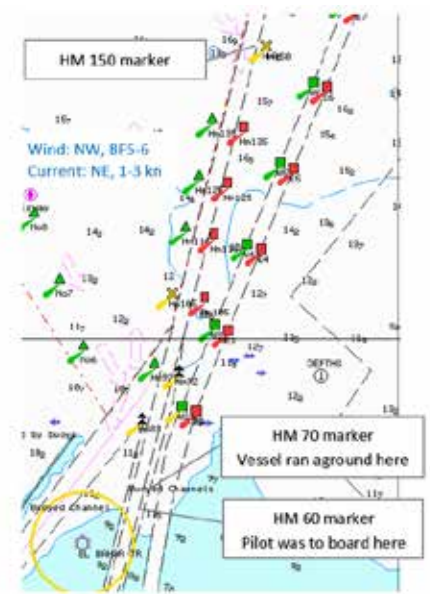
The tanker was on a laden passage from Europe to China, with a draft of 18 mtrs. She arrived at Suez Canal anchorage at 1700 hrs. Instructions by port control were to heave up anchor and have engine st'by at 0400 hrs the following day and be prepared for the pilot to board. At 0400 hrs, vessel was informed that due to bad weather pilot will board the vessel at buoy HM150, which was well inside the fairway.

Vessel entered Suez Canal at 0615 hrs and had taken her position in the convoy, while still waiting for the pilot. The engine room was manned and the deck crew were st'by on radio to pick up the pilot. When vessel was passing HM150, port control informed that pilot will instead join the vessel further inside the channel, at HM60 marker. Speed and course of the vessel at this time are mentioned in the table below. Current was setting north east at a rate of 1-3 knots and wind was from north west, BF 5-6. At 0650 hrs, vessel was instructed to proceed at a heading of 196° and reduce the speed to 8 knots so as to maintain safe distance from the vessel ahead. Other vessels in the convoy were also given the same instructions by the port control. Vessel passed HM92 at 0704 hrs and HM80 at 0711 hrs. Speed and course are mentioned below.

Local time	Location	Speed through water (STW)	Speed over ground (SOG)	Heading	Course over ground (COG)
0640 hrs	Passing HM150	10 knots	9 knots	193°	190°
0704 hrs	Passing HM92	7.5 knots	6.4 knots	197°	189°
0711 hrs	Passing HM80	5.9 knots	5.7 knots	209°	200°

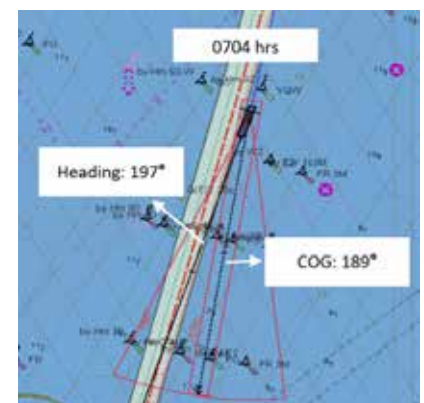
At 0720 hrs, while the pilot boat was still on its way, the vessel ran aground outside the eastern limit near marker HM70. Four tugs were needed to refloat the vessel. Diving operations were undertaken to check the damage to the vessel's bottom and propeller. The chain of red buoy HM70 was found entangled around the propeller. Propeller blades were found to be cracked at the tip and a crack arrestor hole was drilled to stop the its propagation. The entangled chain had to be cut. Whole operation took 4 days.

- The wind and current had a significant effect on the ship, which would have been apparent to the bridge team had they also been monitoring the ground vector (COG). A look at the historical AIS track of the vessel ahead, which had similar dimensions, shows she had given substantial counter helm for wind and current to stay in the channel. For example, when she was passing buoy HM92, her heading was 201°, whereas own ship was steering 197° when passing the same marker.

- Company had an in-house ship handling course for all deck officers and masters, but transits through Suez canal were not simulated in these courses. They were also not designed for large vessels. The investigation report and subsequent preventive actions placed a lot of emphasis on this aspect.
